# New Hampshire Volunteer Lake Assessment Program

## 2002 Interim Report for Pine River Pond Wakefield

# Pine River Pond, Wakefield

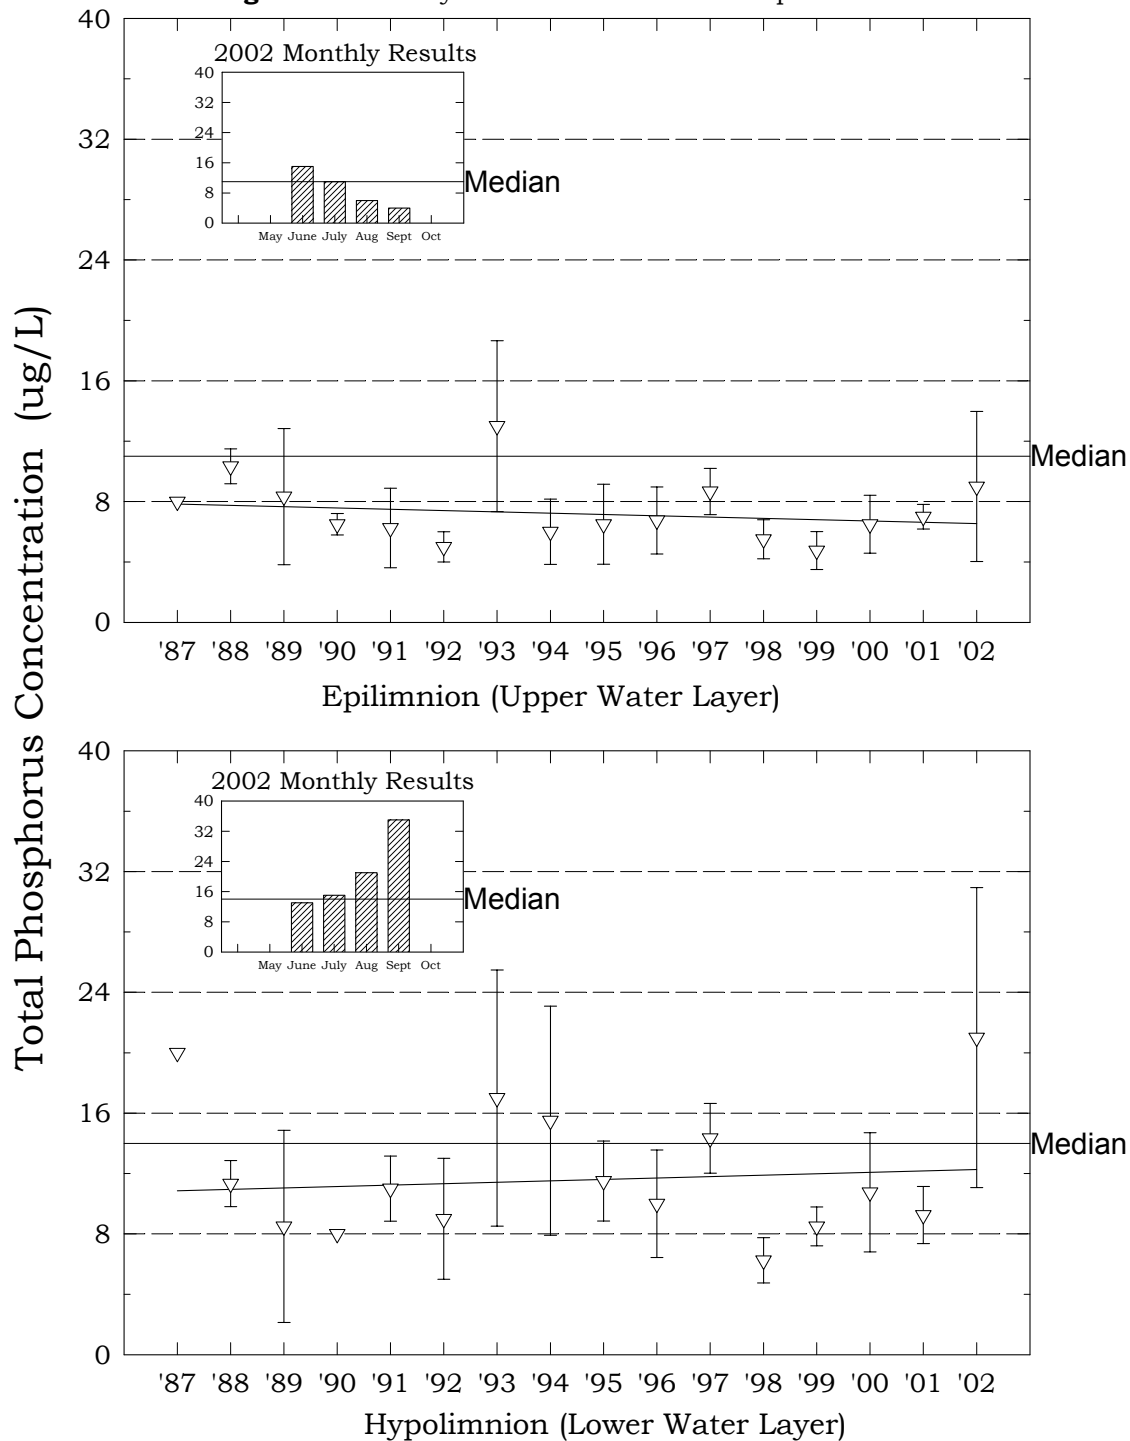
**Figure 3.** Monthly and Historical Total Phosphorus Data.

- **Figure 3 and Table 8:** The graphs in Figure 3 (Appendix A) show the amounts of phosphorus in the epilimnion (the upper layer) and the hypolimnion (the lower layer); the inset graphs show current year data. Table 8 (Appendix B) lists the annual maximum, minimum, and median concentration for each deep spot layer and each tributary since the pond has joined the program.

It is interesting to note that throughout this summer the total phosphorus concentration in the epilimnion (upper layer) **gradually decreased**, while the total phosphorus concentration in the hypolimnion (lower layer) **gradually increased**. It is also important to note that the chlorophyll-a concentration in August and September was **much less than** the concentrations in June and July. This trend may be caused phosphorus contained in the epilimnion at the start of the summer settling to the hypolimnion as the summer progressed. Specifically, as the summer progressed, it is likely that the algal cells near the surface of the pond decomposed and settled to the bottom of the pond, which would cause an increase in the phosphorus concentration near the bottom of the pond.

The historical data for the epilimnion (upper layer) show that the 2002 total phosphorus mean is **less than** the state median. Overall, visual inspection of the historical data trend line for the epilimnion shows **a relatively stable** total phosphorus trend, which means that the concentration has **remained approximately the same and less than the state median** (with the exception of the 1993 sampling season) in the epilimnion since monitoring began.

The historical data for the hypolimnion (lower layer) show that the 2002 total phosphorus mean is **much greater than** the state median. Overall, visual inspection of the historical data trend line for the hypolimnion shows **a variable** total phosphorus trend, which means that the concentration has **fluctuated** in the hypolimnion since monitoring began.

One of the most important approaches to reducing phosphorus loading to a waterbody is to continually educate watershed residents about its sources and how excessive amounts can adversely impact the ecology and value of lakes and ponds. Phosphorus sources within a lake or pond's watershed typically include septic systems, animal waste, lawn fertilizer, road and construction erosion, and natural wetlands. If you would like to educate watershed residents about how they can help to reduce phosphorus loading into the pond, please contact the VLAP Coordinator.
